PERFORMANCE INNOVATION LABORATORIES

**Failure Analysis of
Vibration Test Cards for Crane
Job ID: TOL0901051**

Report by: Eva Kosiba
Title: Operations Engineering Advisor

Company Name: Crane Division, Naval Surface Warfare Center (NSWC)

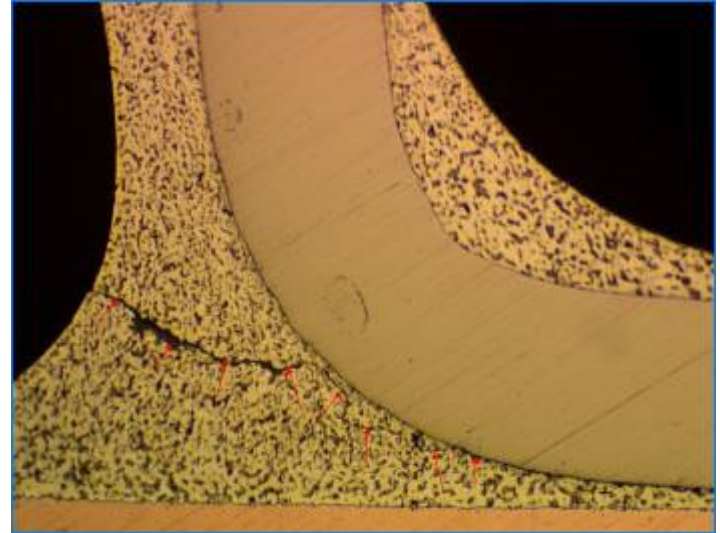
Figure 31: cross section, SN61, U62, right lead, solder crack, 200x

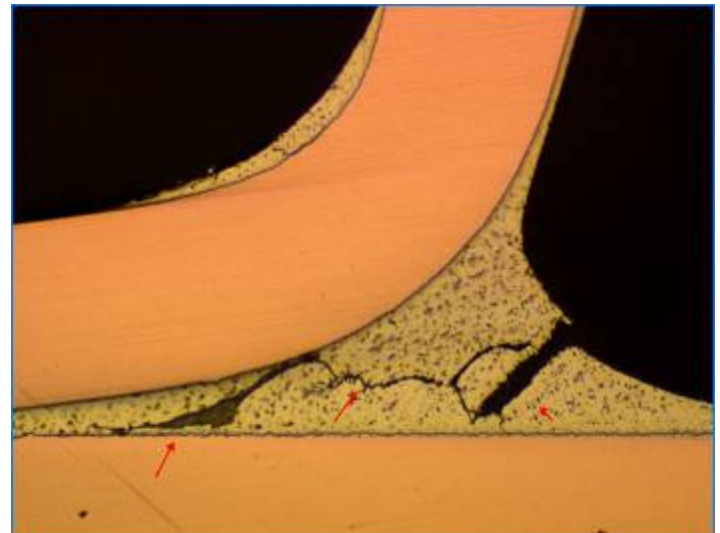
Figure 33: cross section, SN62, U31, left lead solder crack, 200x, a

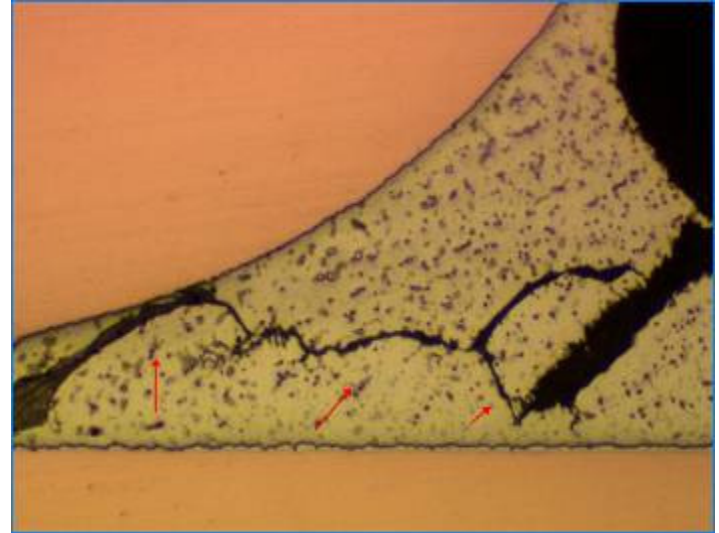
Figure 35: cross section, SN62, U31, left lead solder crack, 400x, a

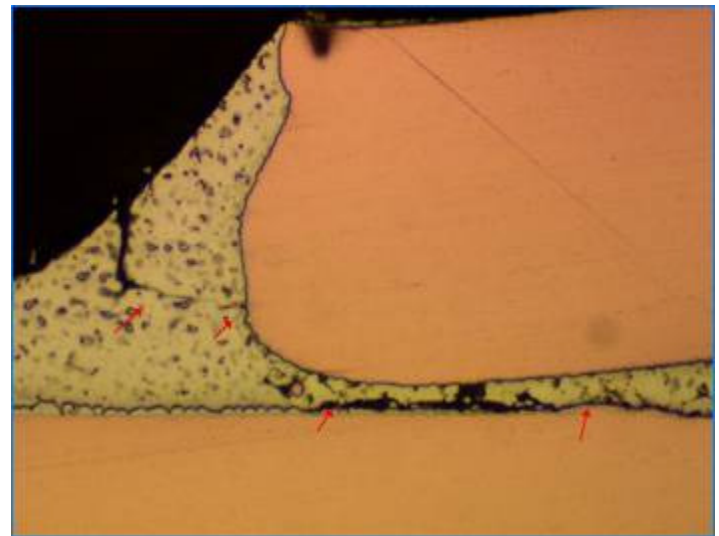
Figure 37: cross section, SN62, U31, left lead solder crack, 400x, c

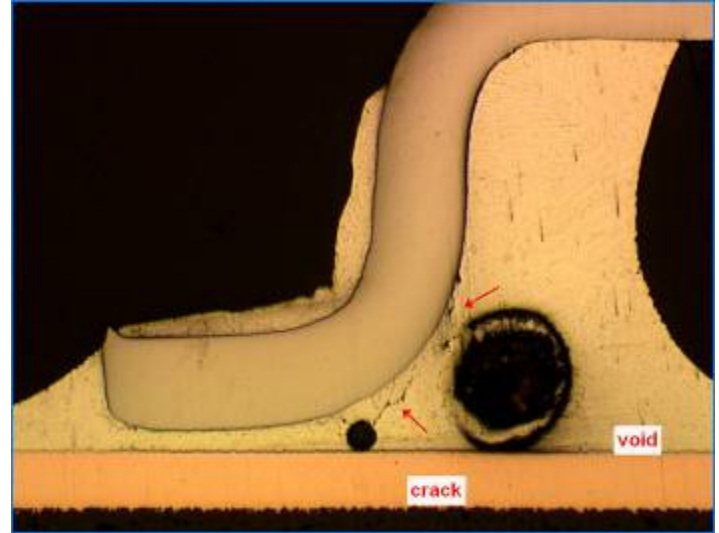
Figure 39: cross section, SN62, U61, left lead solder crack and voids, 100x

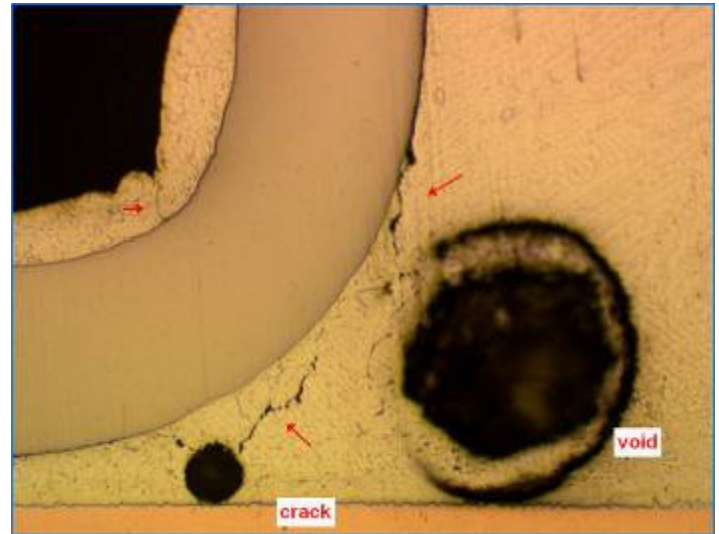
Figure 41: cross section, SN62, U61, left lead solder crack and voids, 200x

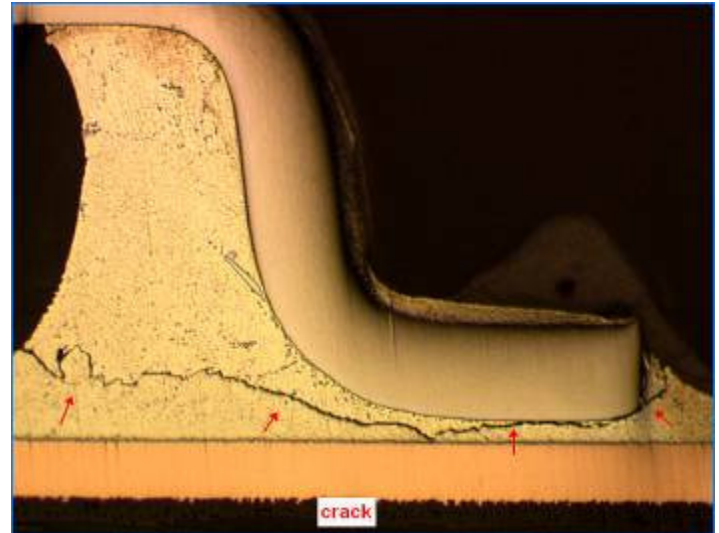
Figure 47: cross section, SN62, U61, right lead solder crack, 100x

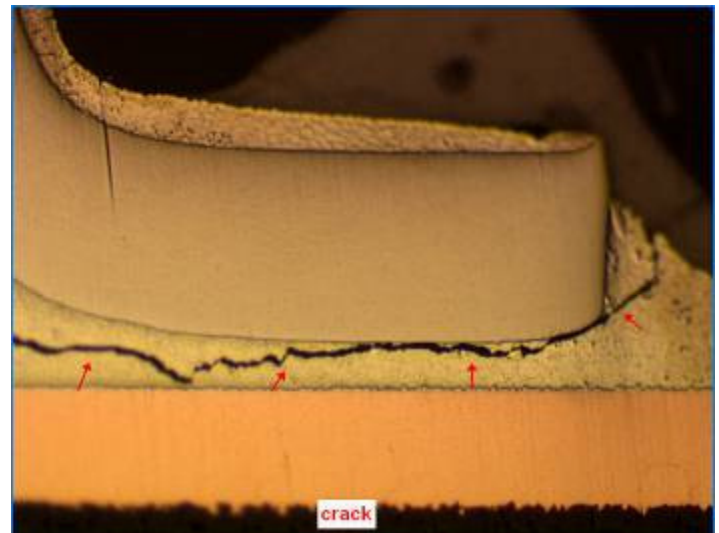
Figure 49: cross section, SN62, U61, right lead solder crack, 200x b

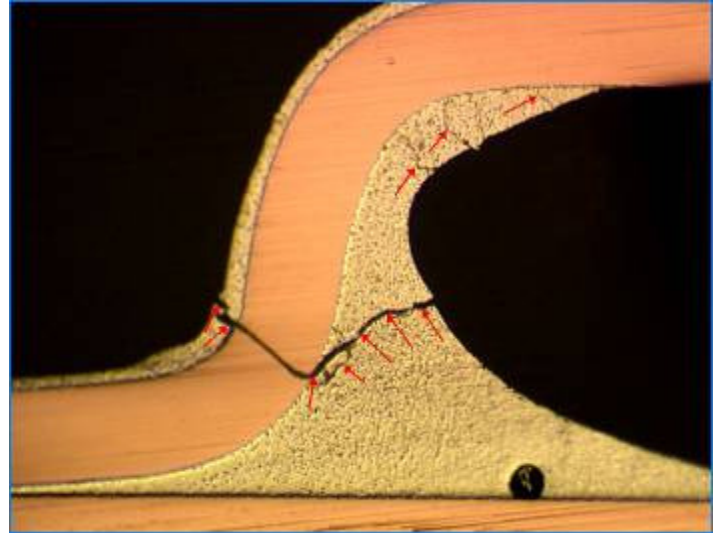
Figure 55: cross section, SN63, U20, left lead and solder crack and void, 100x

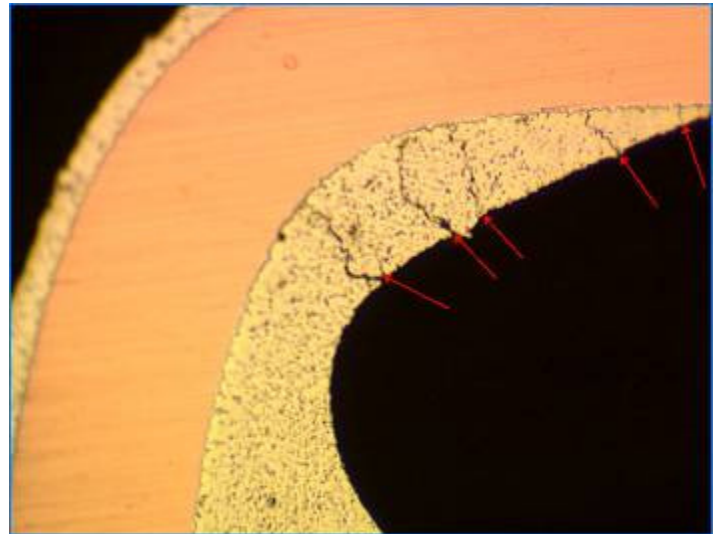
Figure 57: cross section, SN63, U20, left lead and solder crack and void, 200xb

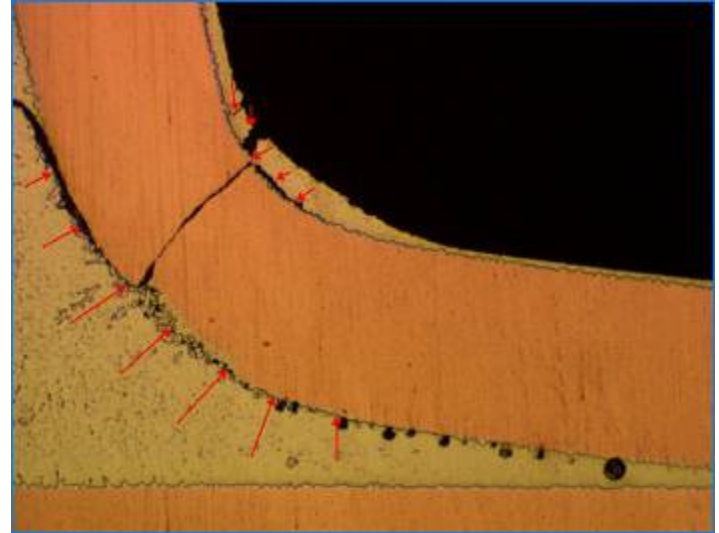
Figure 59: cross section, SN63, U20, right lead and solder crack and voids, 200xa

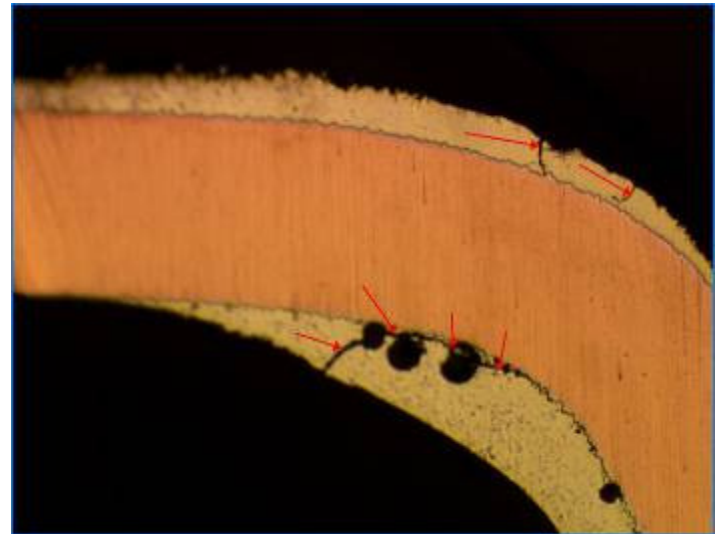
Figure 61: cross section, SN63, U20, right lead and solder crack and voids, 200xc

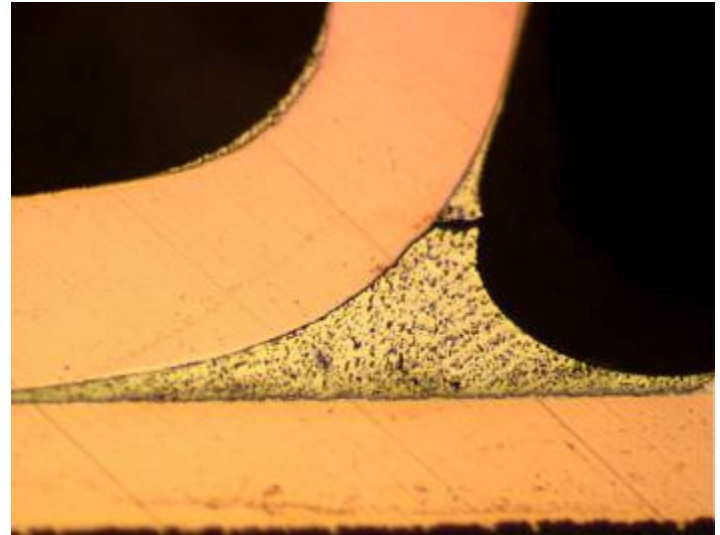
Figure 63: cross section, SN63, U31, left lead solder crack, 200xb

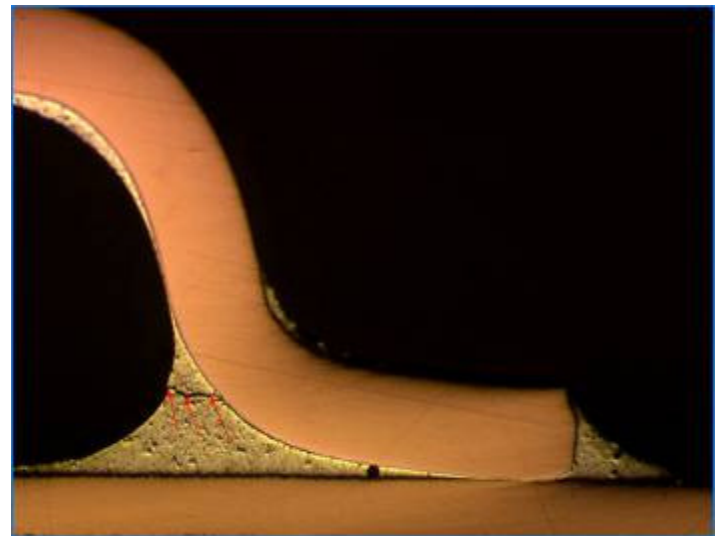
Figure 65: cross section, SN63, U31, right lead solder crack, 100x

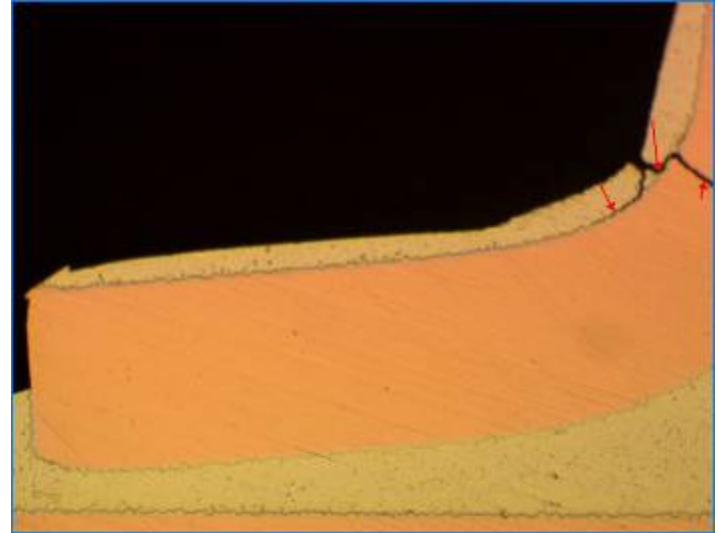
SN63 U41 and SN61 U20 illustrate TQFP-144 packages which were not reworked and therefore contain only Pb-free solders. All of the components experienced broken leads on at least one side of the component, usually both.

Figure 67: cross section, SN63, U41, left lead crack, 200xa

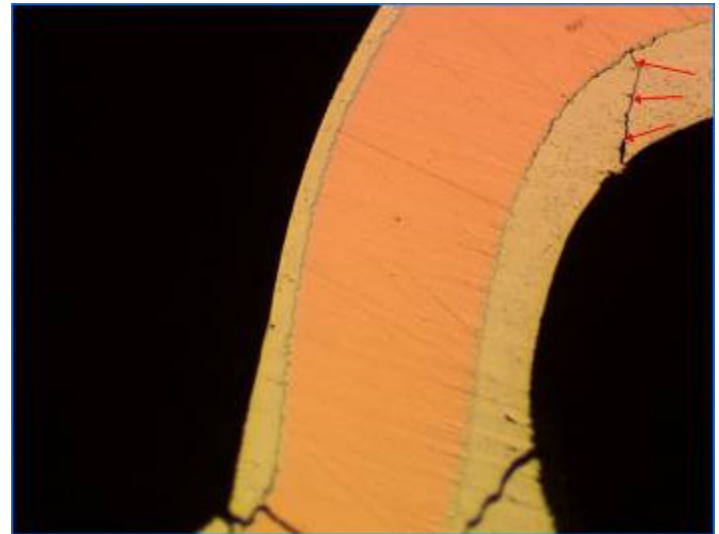
Figure 69: cross section, SN63, U41, left lead crack, 200xc

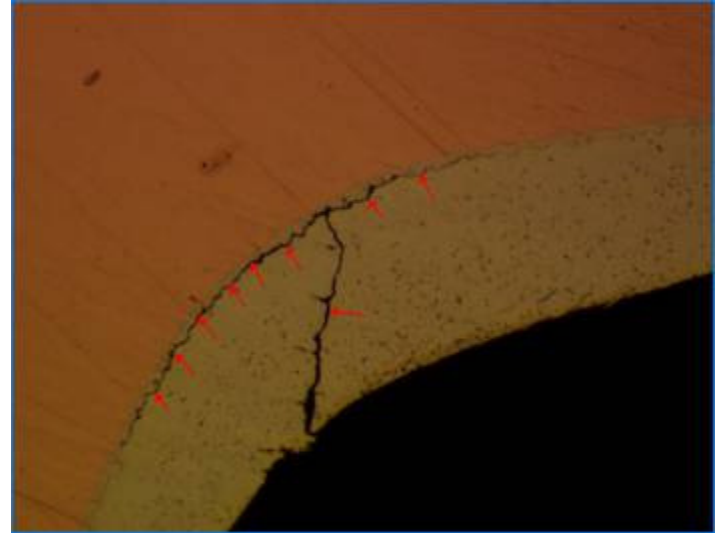
Figure 71: cross section, SN63, U41, left lead crack, 400x

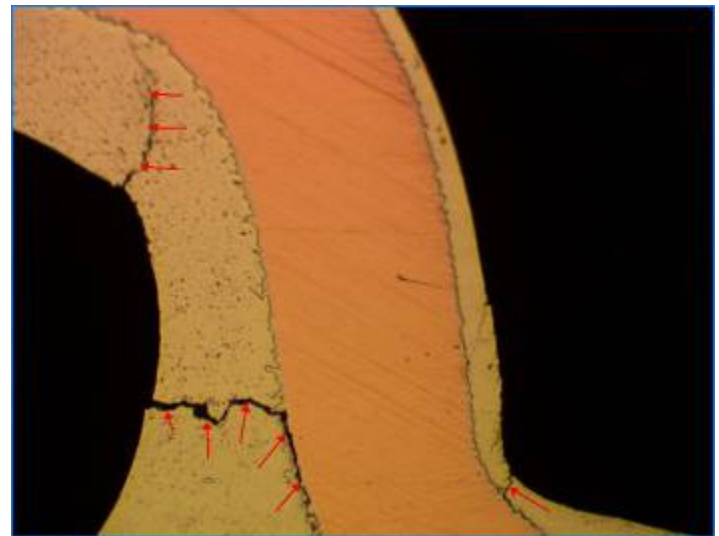
Figure 73: cross section, SN63, U41, right lead solder crack, 200x

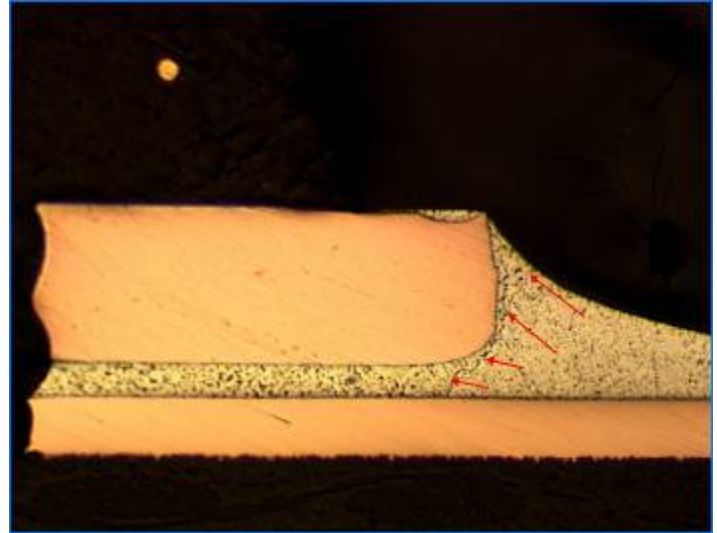
Figure 83: cross section, SN63, U54, right pad solder crack, 100x

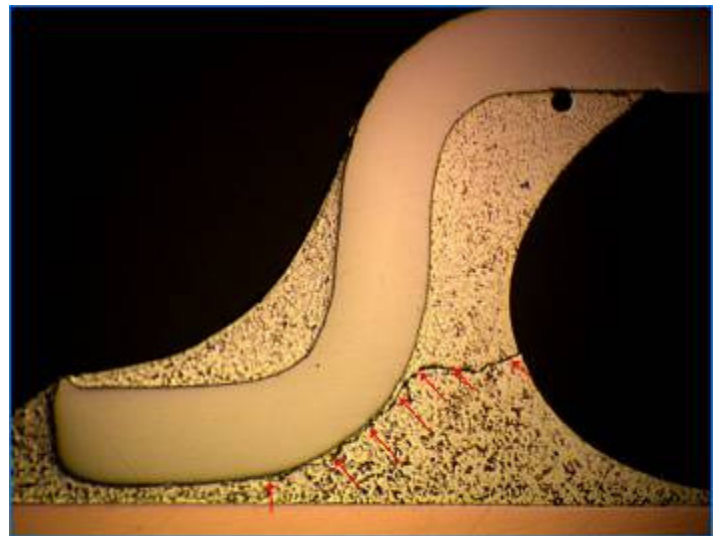
Samples SN63 U61 and SN65 U62 are examples of parts which underwent one re-work cycle with SnPb solder. They have Sn and SnBi finishes respectively and both components showed significant cracking within the solder at both sides of the component. This is consistent with all parts which have undergone one re-work cycle.

Figure 85: cross section, SN63, U61, left lead solder crack, 100x

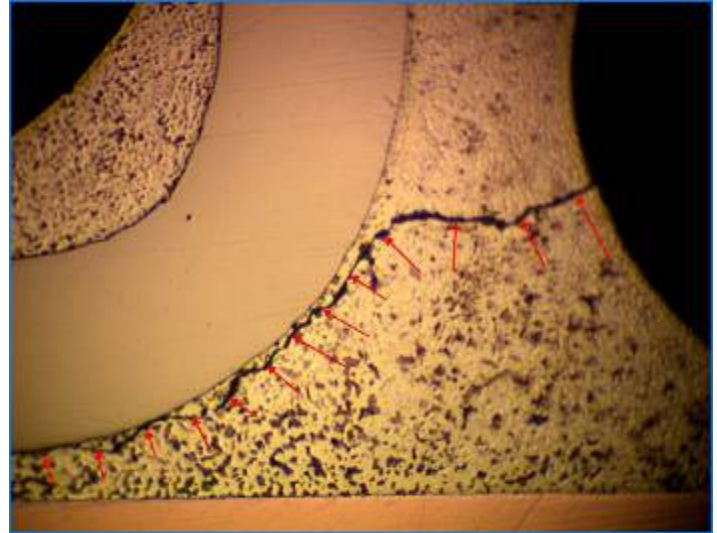
Figure 87: cross section, SN63, U61, left lead solder crack, 200xb

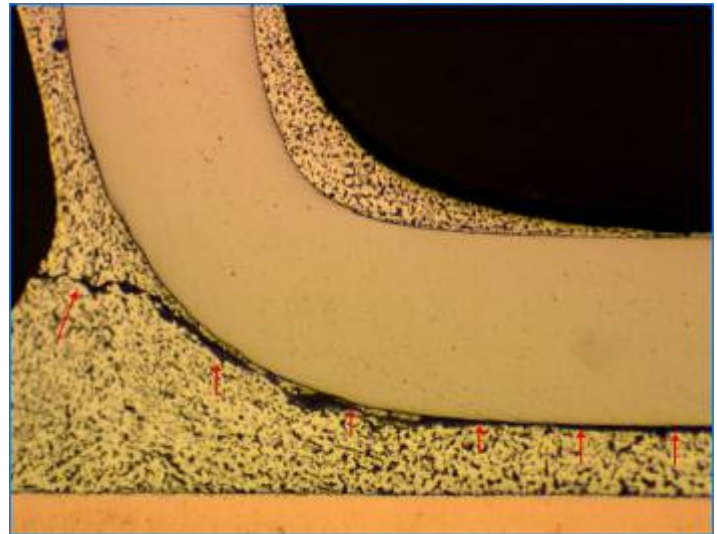
Figure 89: cross section, SN63, U61, right lead solder crack, 200xa

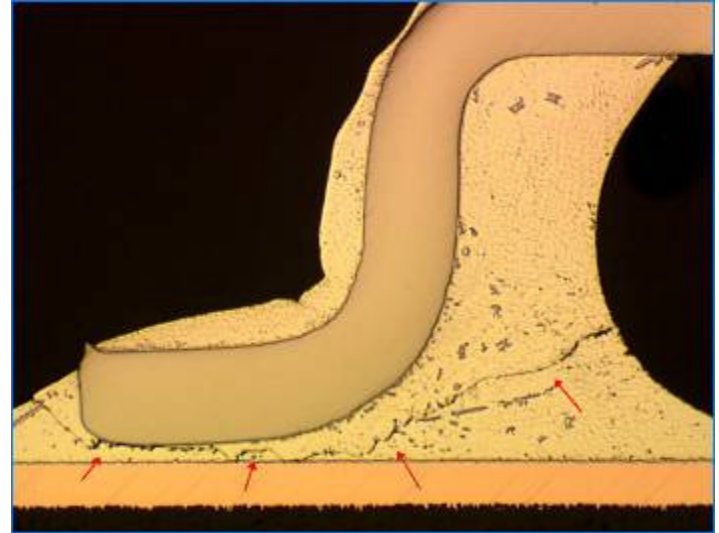
Figure 91: cross section, SN64, U62, left lead solder crack, 100x

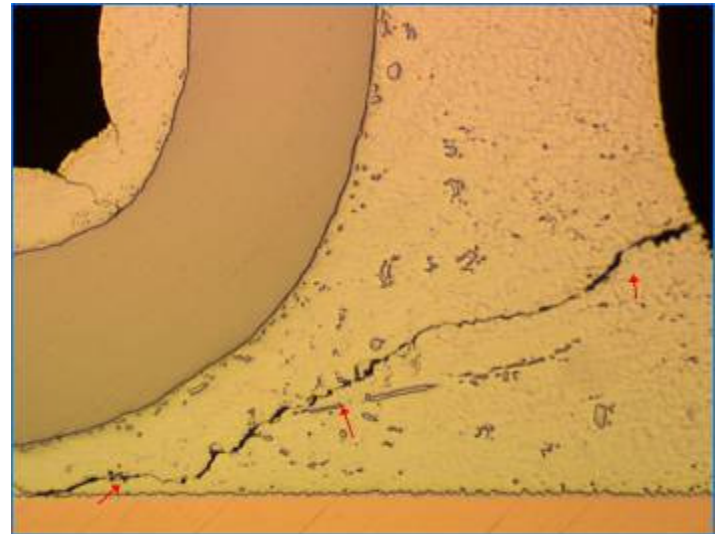
Figure 93: cross section, SN64, U62, left lead solder crack, 200xb

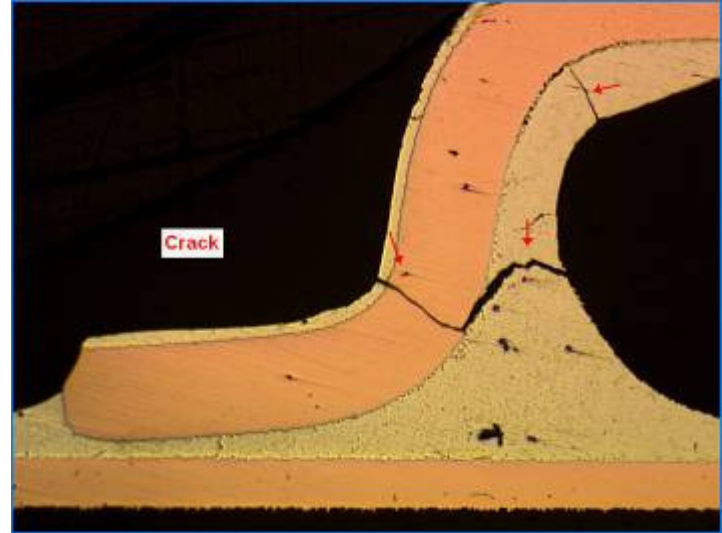
Figure 95: cross section, SN65, U20, left lead and solder crack, 100x

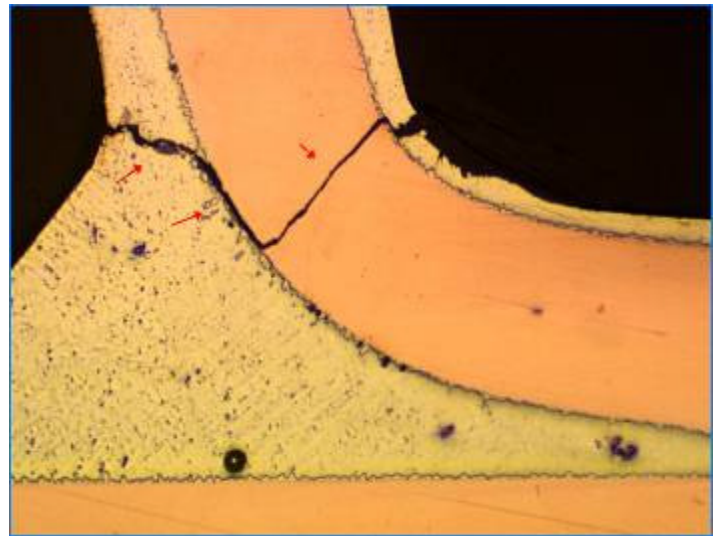
Figure 99: cross section, SN65, U20, right lead and solder crack, 200x

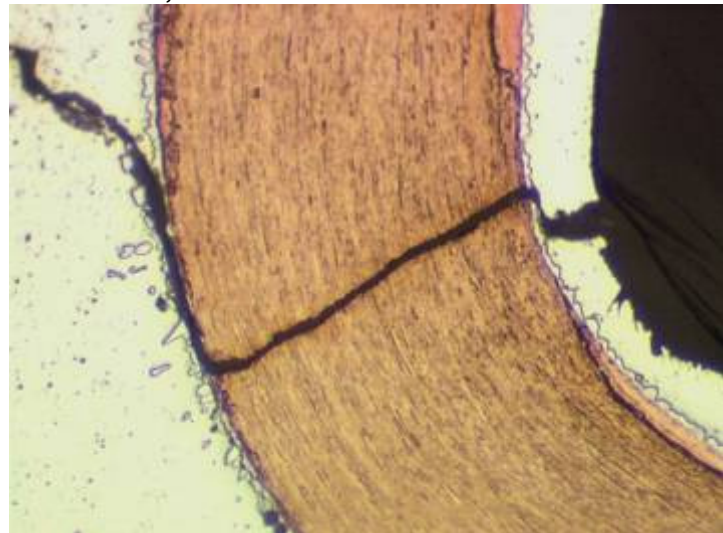
Figure 101: cross section, SN65, U20, right lead, after etching, 400x

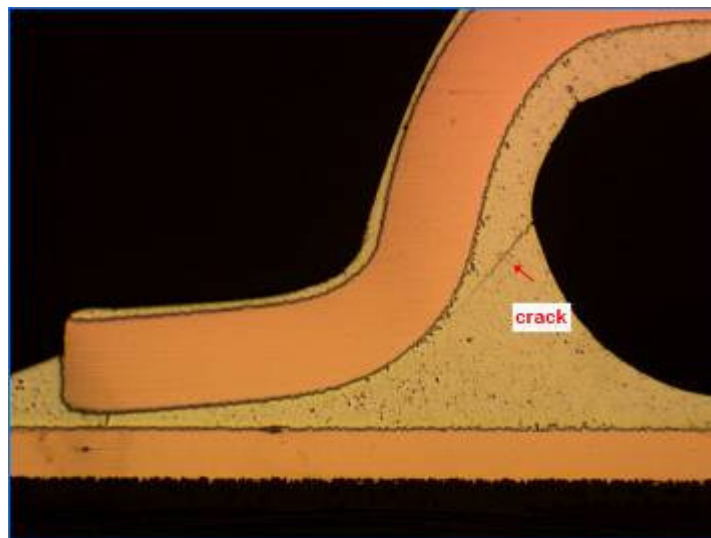
Figure 107: cross section, SN65, U41, left lead, partial solder crack, 100x

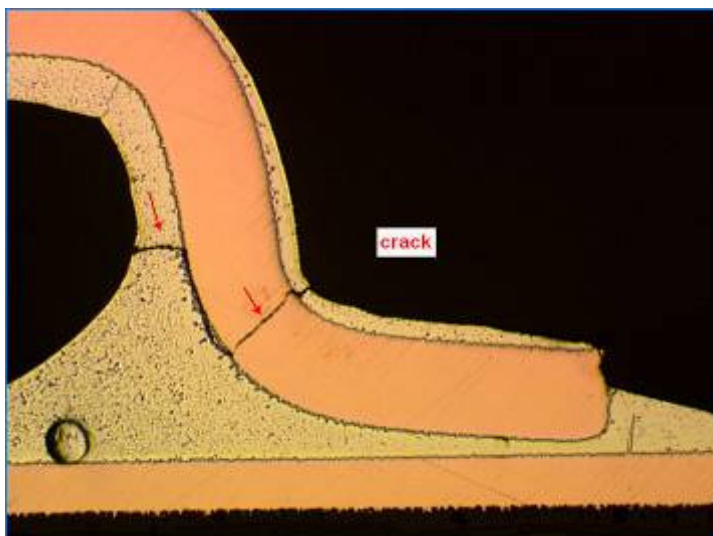
Figure 108: cross section, SN65, U41, right lead and solder crack, 100x

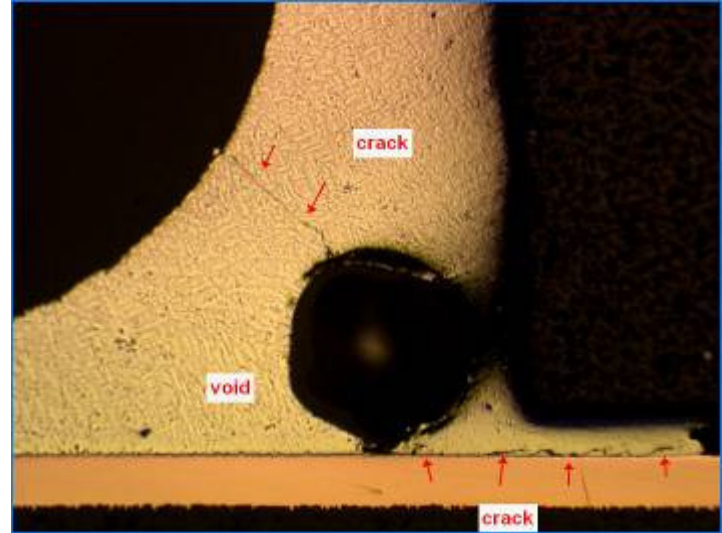
Figure 111: cross section, SN65, U52, left lead solder crack and void, 100x

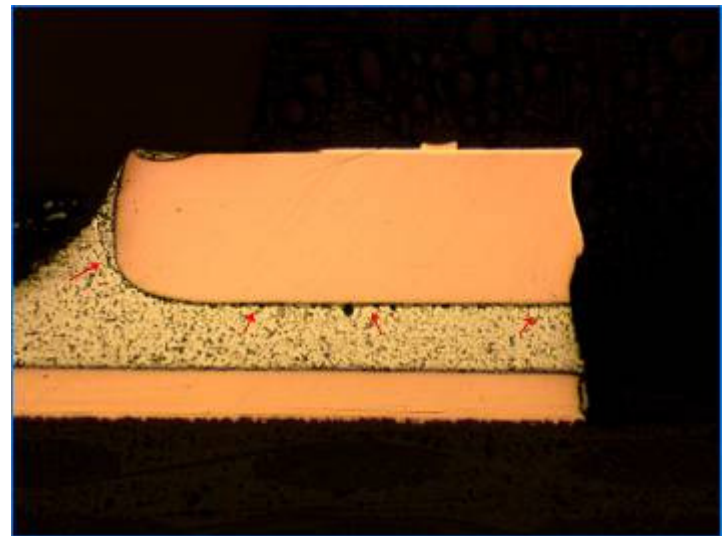
Figure 113: cross section, SN65, U54, left lead solder crack, 100x

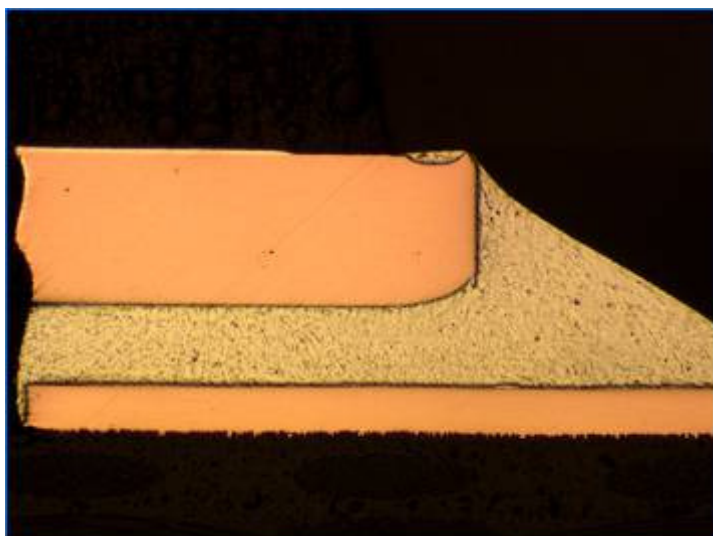
Figure 116: cross section, SN65, U54, right lead , 100x

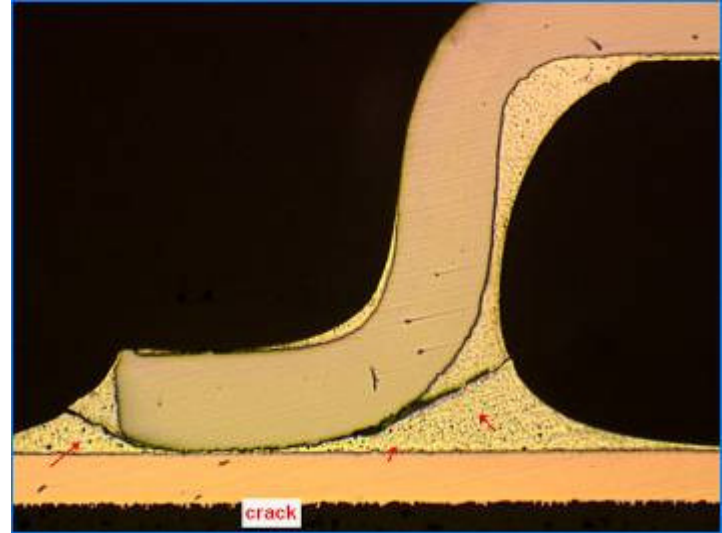
Figure 119: cross section, SN65, U62, left lead and solder crack, 100x

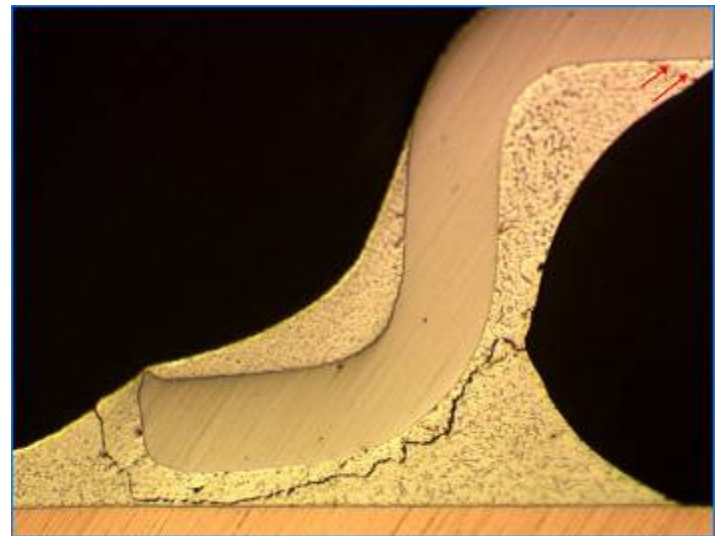
Figure 121: cross section, SN66, U61, left lead solder crack, 100x

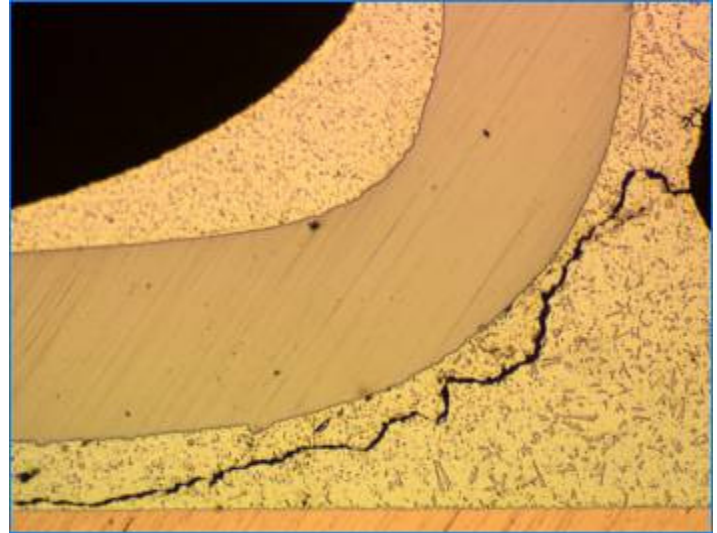
Figure 123: cross section, SN66, U61, left lead solder crack, 200xb

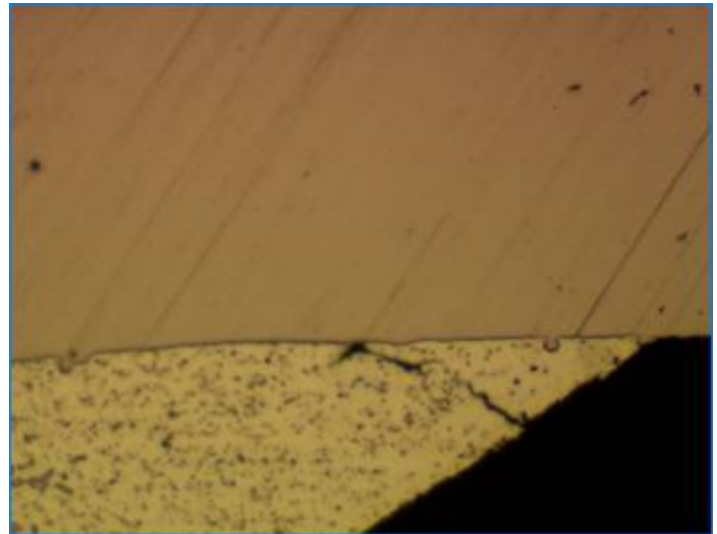
Figure 125: cross section, SN66, U61, left lead solder crack, 400x

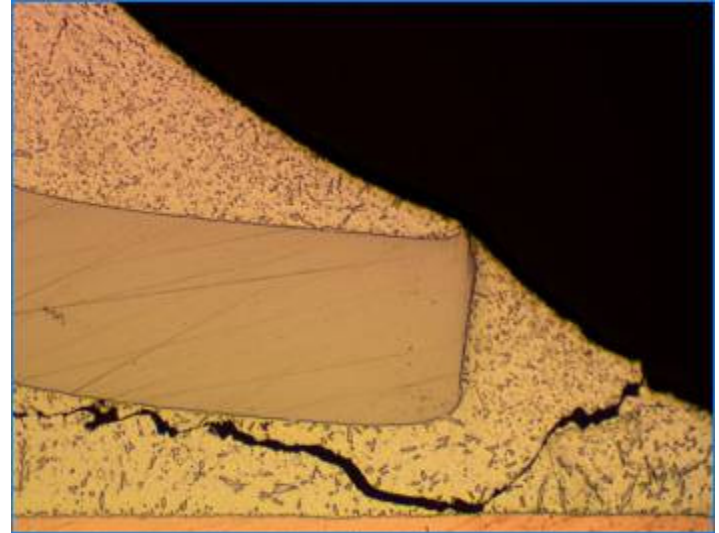
Figure 127: cross section, SN66, U61, right lead solder crack, 200xa

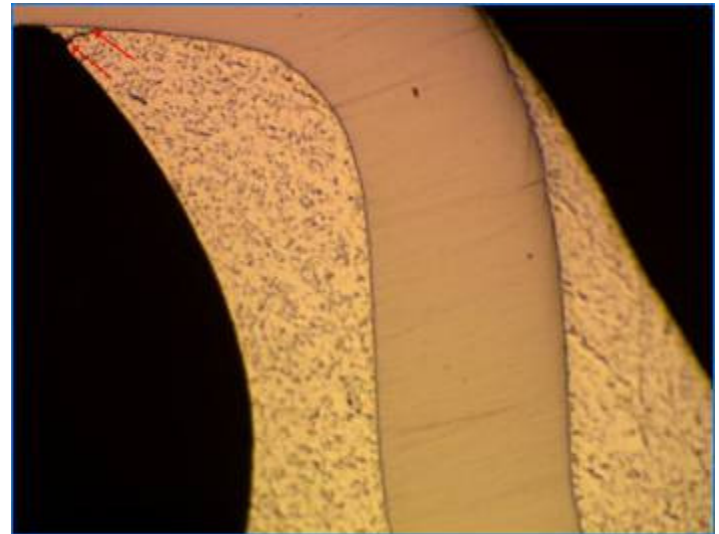
Figure 129: cross section, SN66, U61, right lead solder crack, 200xc

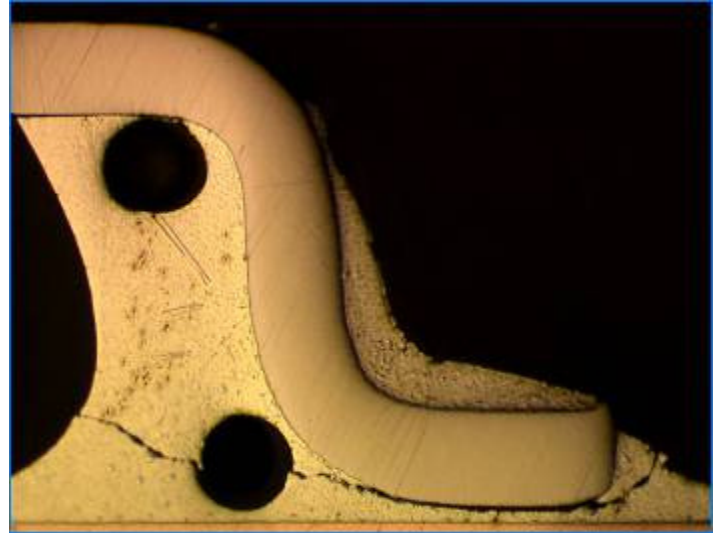
Samples SN79 U12 and SN66 U62 are examples of TSOPs which did not undergo any re-work. They have Sn and SnBi finishes respectively. Both experienced severe solder cracking in leads on both sides of the component.

Figure 135: cross section, SN66, U62, right lead solder crack and void, 100x

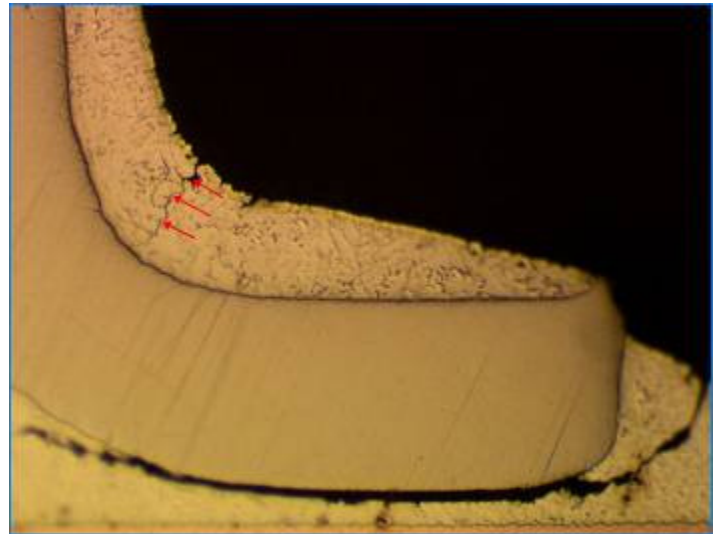
Figure 137: cross section, SN66, U62, right lead solder crack, 200xa

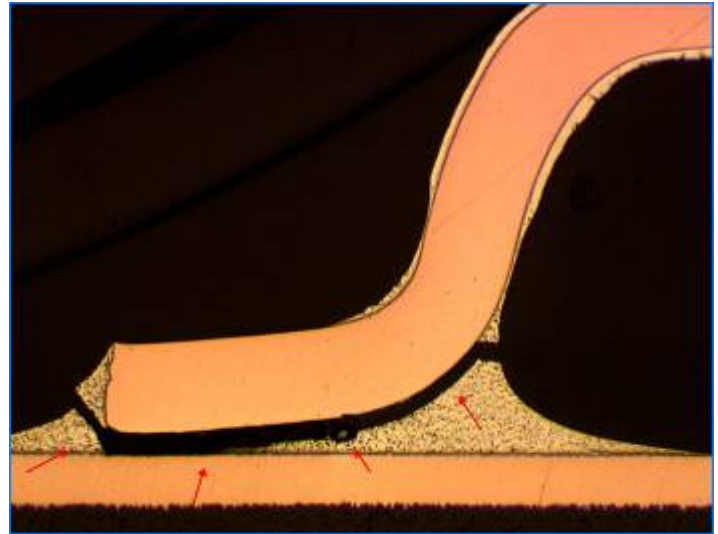
Figure 139: cross section, SN67, U31, left lead solder crack, 100x

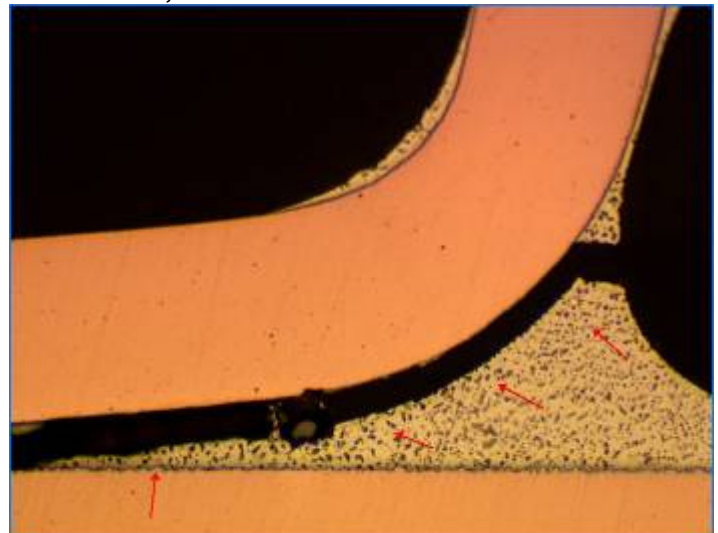
Figure 141: cross section, SN67, U31, left lead solder crack, 200xb

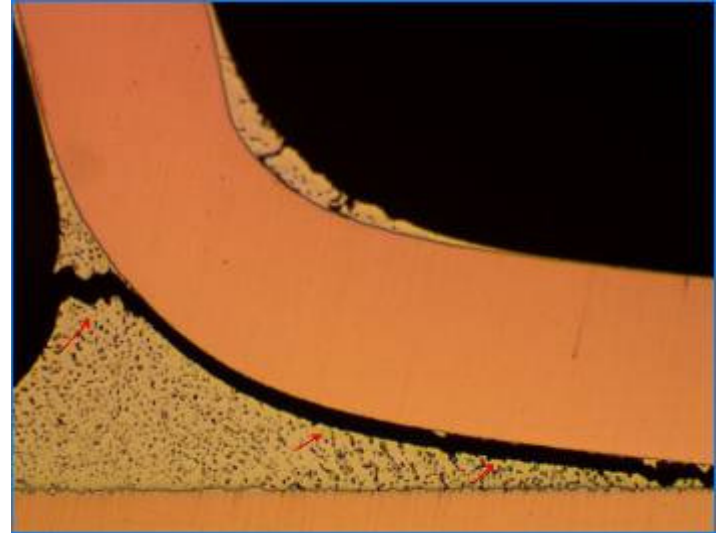
Figure 143: cross section, SN67, U31, right lead solder crack, 200xa

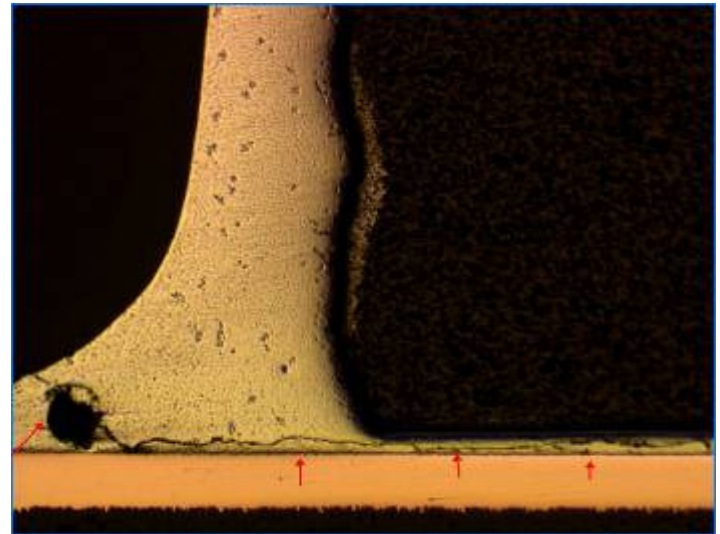
The cross sections of all CCLC-20 packages were performed on corner pads. Each cross section revealed cracking across the length of the solder. SN67 also showed voiding. In this case the crack traveled along the void.

Figure 145: cross section, SN67, U52, left lead solder crack, 100x

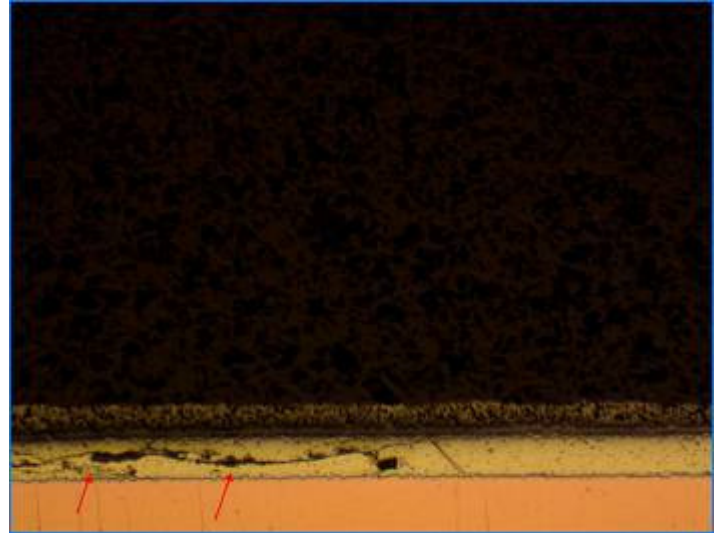
Figure 147: cross section, SN67, U52, left lead solder crack, 200xb

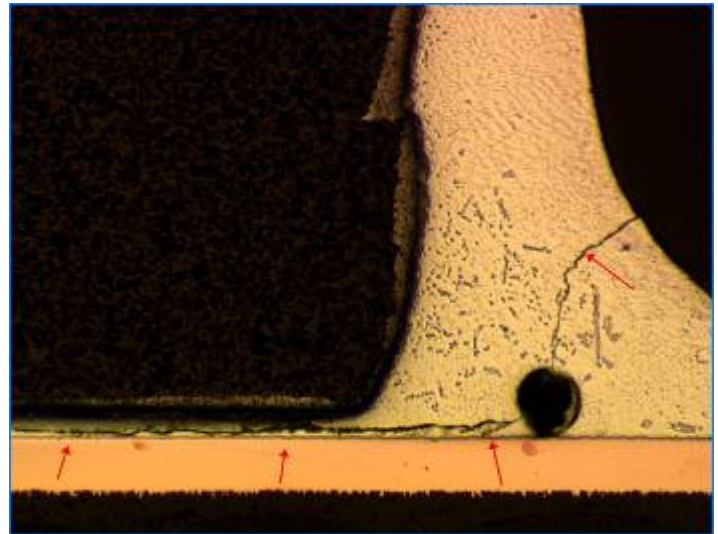
Figure 149: cross section, SN67, U52, right lead solder crack, 100x

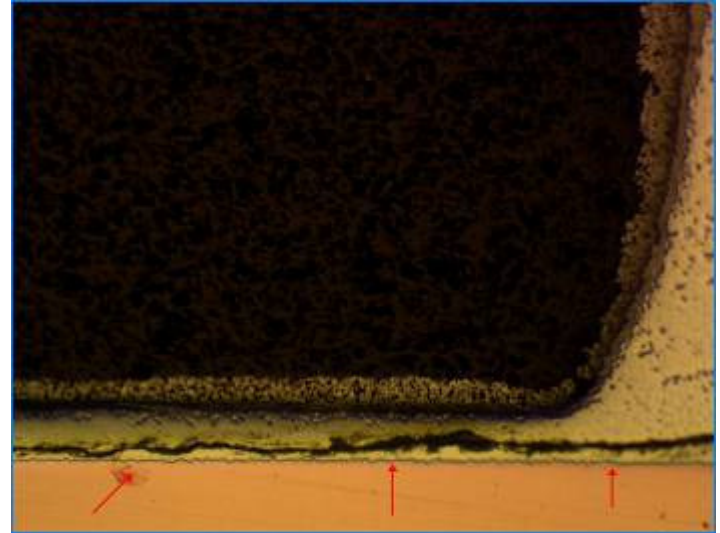
Figure 151: cross section, SN67, U52, right lead solder crack, 200xb

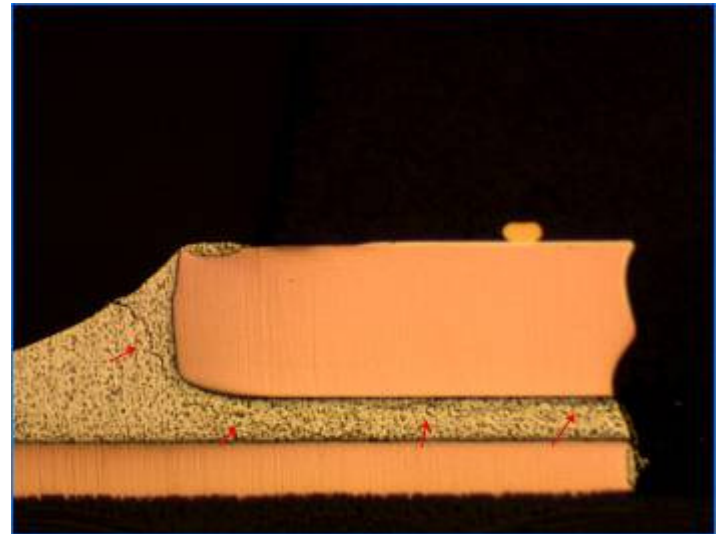
Figure 153: cross section, SN67, U54, left lead solder crack, 100x

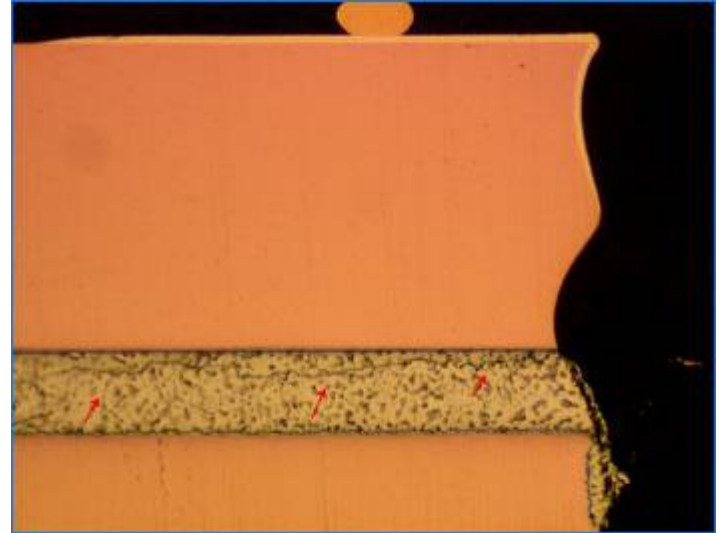
Figure 155: cross section, SN67, U54, left lead solder crack, 200xb

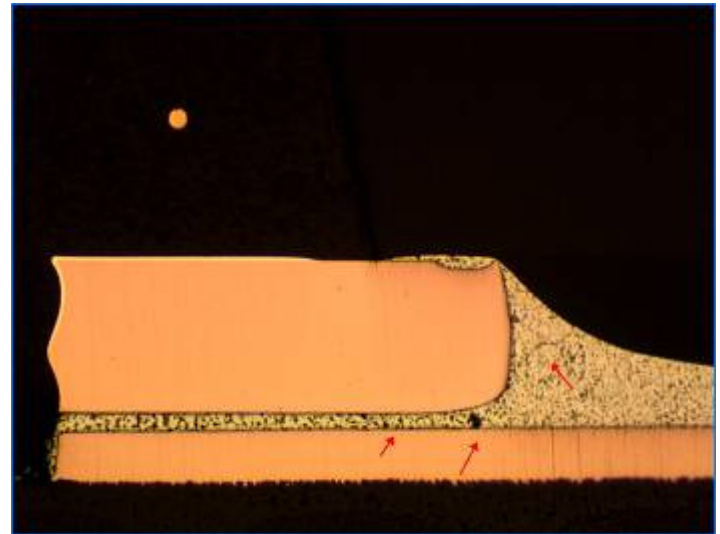
Figure 157: cross section, SN67, U54, right lead solder partial crack, 100x

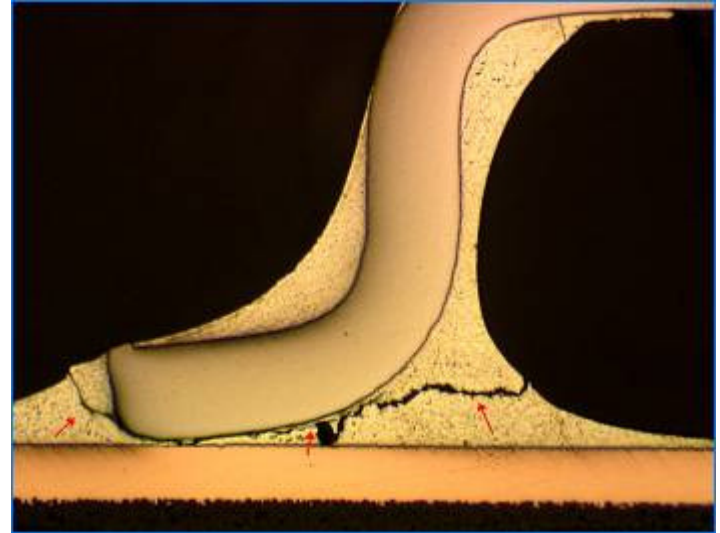
Figure 159: cross section, SN67, U61, left lead solder crack, 100x

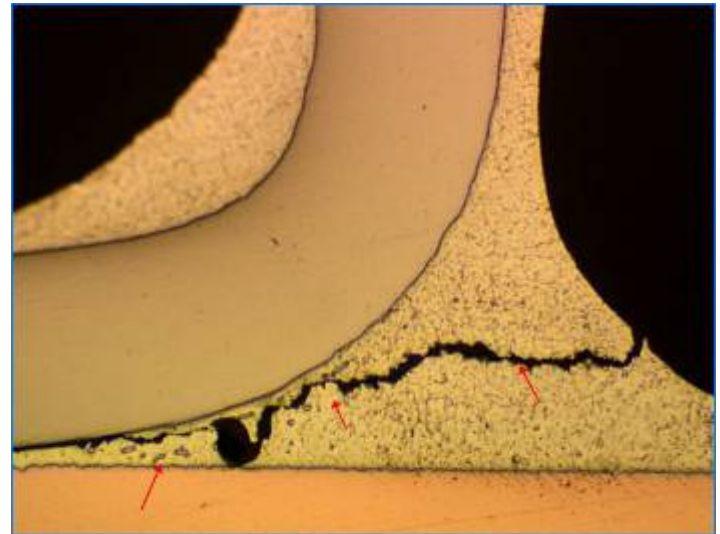
Figure 161: cross section, SN67, U61, left lead solder crack, 200xb

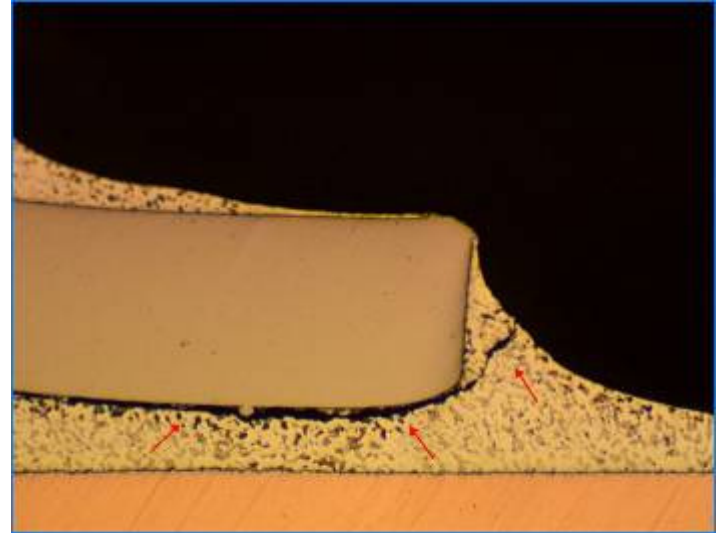
Figure 163: cross section, SN67, U61, right lead solder crack, 200xa

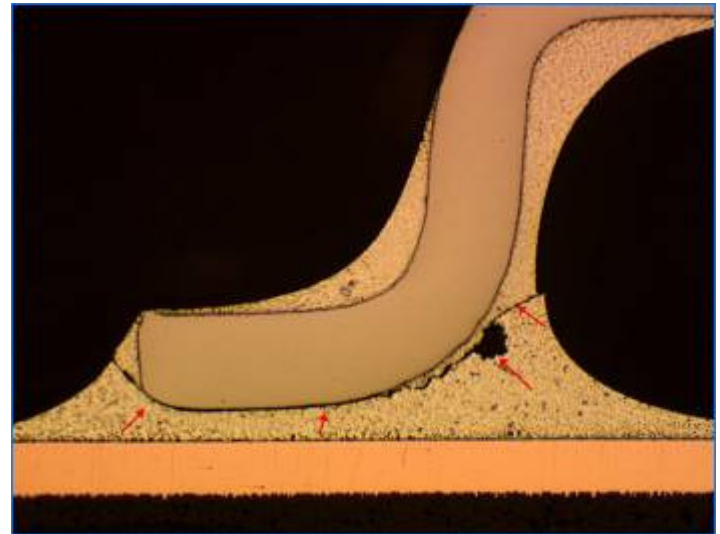
Figure 165: cross section, SN67, U62, left lead solder crack, 100x

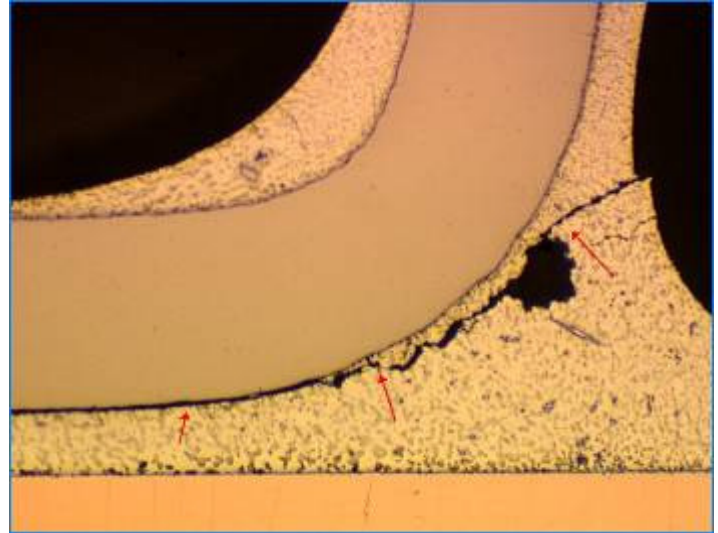
Figure 167: cross section, SN67, U62, left lead solder crack, 200xb

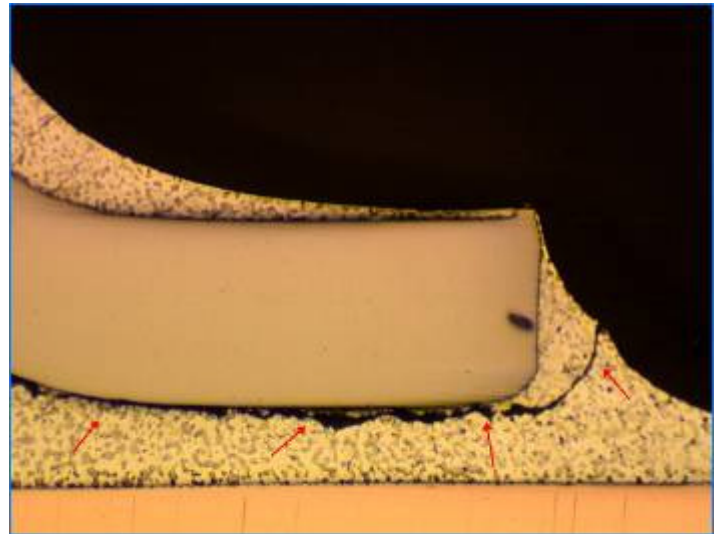
Figure 169: cross section, SN67, U62, right lead solder crack, 200xa
